5

F Street

The Traffic Artery

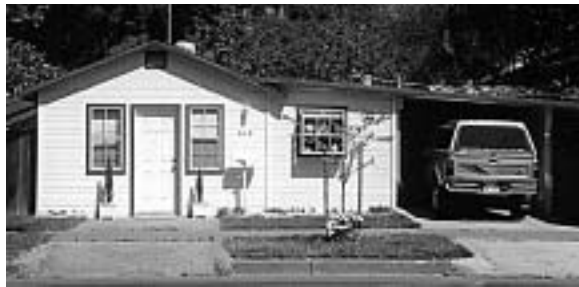
The building at 619 Fifth Street (Fig. 5.1) is an example of an odd but wonderfully developed structure that is simply the rear part of 503 F. It is not on the 1921 or 1933 Sanborn maps, but the original garage portion appears on the 1953 Sanborn. That map shows an overhang to the right that is now enclosed while yet another overhang has been added to the right. This is an example of creating a home by slow, over-the-years creep.

5.1. 619 Fifth Street, an example of “abode creep.”

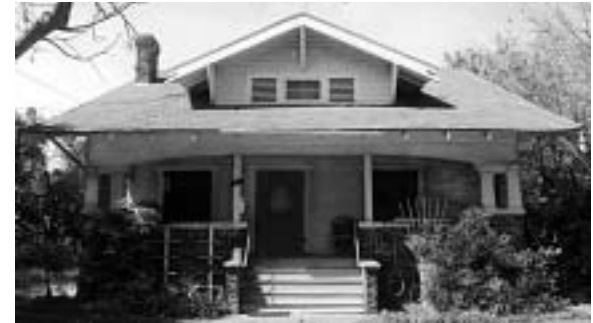
5.2. 513 F Street. (The Bentley Home).

This symmetrical one and a half story Craftsman bungalow has a gabled roof with a generous broadly arched porch under the street side eaves that extends the full width of the house. Battered pillars support the roof at the porch corners. Slender brackets support gable overhangs. Surface materials are clapboard, shingles, wood with a clinker brick porch base. A dormer window with vents projects from the gabled roof (HEC, 227).

They also report on the long-standing multiple-occupancy of this house, a feature that is not immediately apparent from the street. “The building has been altered to accommodate additional units of

dwelling space and an added stair extends to the top story on the north side to provide access” (HEC, 227; Fig. 5.2).

The 1980 HEC surveyors declared that 513 F’s “architectural values provide its primary significance. The bungalow is a good representative of Craftsman styling with typical materials, form, and image of the era. Although not large, the structure’s composition and scale add to its visual importance and presence” (HEC, 227-228).

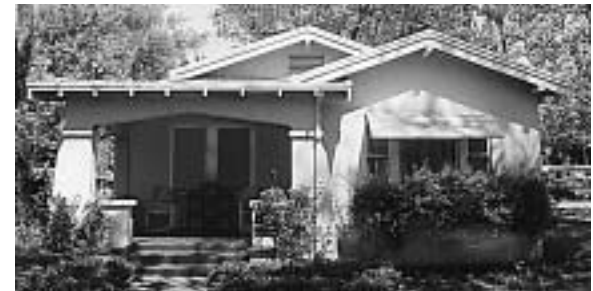
5.3. 621 Sixth Street.

The special features of this stuccoed Craftsman include its “intersecting gable roofs perpendicular to the street. The gable over the main portion of the house is punctuated by an attic vent. The porch has a gable roof with the ridge running parallel to the street [and] is supported by two canted piers on bases with an additional area to be used as planter holders. The porch has a low arch that comes to a point in the center. A large tripartite window with an awning occupies the east end of the front elevation” (ARG, 281).

Constructed in the 1920s, 621 Sixth Street (Fig. 5.3) “is an excellent example of a Craftsman style bungalow [and] . . . is a strong contributor to a neighborhood rich in bungalow style structures,” opined the 1996 ARG surveyors (ARG, 282).

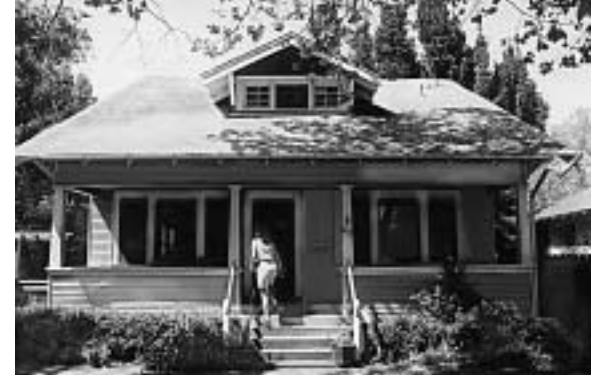
5.6. 619 F Street.

Constructed sometime between 1910 and 1920, “this two story . . . home has a gable roof running parallel to the street. A large tripartite dormer window with its own gable punctures the main roof. Both roofs have bracketed overhangs. A front porch

runs the entire length of the house. Four tapered, classically inspired square columns support the porch and rest on a parapet wall. The house is clad with horizontal wood siding except in the gables of the main roof which are shingled. The front door is slightly off center and is the only asymmetrical feature of the front elevation. Large tripartite windows flank either side of the front door” (ARG, 317).

The 1996 historical surveyors considered 619 F Street (Fig. 5.6) “a particularly well designed and proportioned Craftsman style house” (ARG, 318).

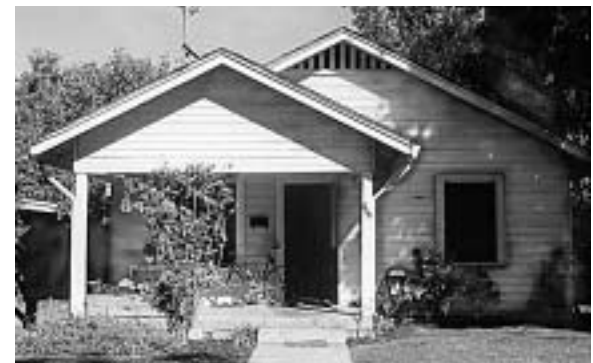
5.7. 620 F Street.

Constructed in the early 1930s or late 1920s, 620 F (Fig. 5.7) has a “projecting porch supported by thin posts, . . . a gable roof that is perpendicular to the street [and] . . . is sheathed in horizontal wood siding” (ARG, 319).

ARG surveyors note that “the roof of the main house mimics the form of the front porch and has an attic vent. The front door is accessed off the small porch and there is one double hung window on the south side of the front elevation” (ARG, 319).

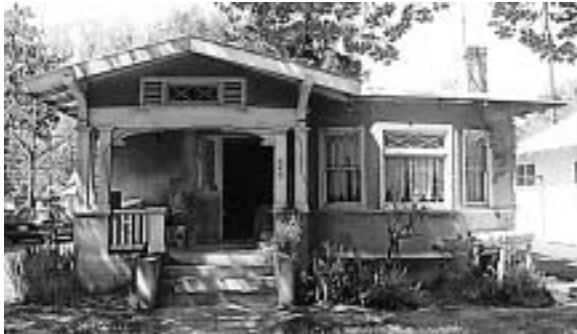
5.8. 643 F Street.

Specifically, “the proportions of the house emphasize its horizontality The shallow hipped roof . . . intersects the low gabled roof of the porch over the entrance The porch roof is supported by double posts set on stucco piers. The brackets at the eaves add ornament to the roofline. A shallow slanted cantilevered bay extends from the front of the house” (HEC, 229; ARG, 321).

The 1980 historical surveyors report that 643 F Street (Fig. 5.8) was constructed in 1916 “solely as an investment, a common past and present enterprise in Davis, and has always been used as a rental” (HEC, 230). Even so, 643 F Street has architectural value because of the “quality and execution of detailing combined with [its] careful proportions” (HEC, 230).

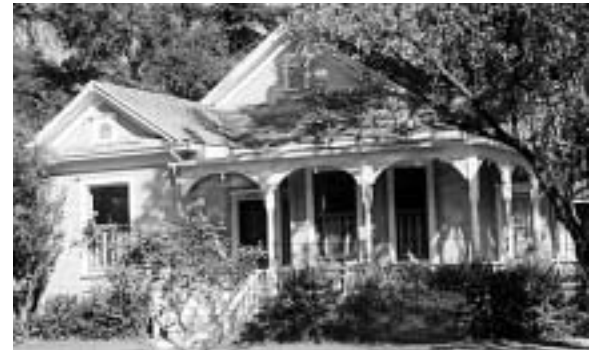
5.10. 623
Seventh Street,
The Anderson-
Hamel House.

- **ARCHITECTURE.** A Queen Anne cottage, the HEC and ARG surveyors describe 623 Seventh as composed of two gabled sections integrated by a hipped porch roof. The narrow clapboard of the walls is contrasted with the fishscale shingles of the gable ends. There are louvered vents in the gables, with cornice moldings, and a dentil course at the line of the soffited eaves.

The porch has turned columns, jigsaw panels with pendant, and a railing made of geometrically arranged rectangles. [It] is accessed via four steps. Several window openings occur under the roof of the porch which turns the corner on the east elevation (HEC, 179; ARG, 125).

Following the observations in Ch. 1 on windows taller than they are wide, note the conspicuous presence of tall windows in 623 Seventh. Indeed, one of the owners, Noni Storm, has remarked on the key importance of these windows in providing “excellent natural lighting” and avoiding a “dark feeling” (Tyler 1992).

623 Seventh Street is a 1903 Queen Anne cottage which was originally located five blocks south of this site, at the northwest corner of Second and F streets, and moved to its current location in the late 1940s (Fig. 5.10).

- **DESECRATION AND RESTORATION.** In the 1950s the house was “modernized” by removing all its external Queen Anne features and it became a decaying, nondescript rental.

Noni and David Storm purchased it in the early 1970s and went to great pains to restore it to its original appearance. This process included the good luck of discovering the original gingerbread woodwork in the four-foot crawl space under the house. Other details were reconstructed from an early photograph of the house (Tyler 1992).
