State	of C	alifor	nia	_	The	Reso	urces	Agen	су
<b>DEPA</b>	RTM	IENT	OF	PAR	KS	AND	<b>RECRI</b>	EATIC	N
PRI	M A	<b>VRY</b>	R	FC	0:	RD

\*Resource Name or Address 516 F Street

\*P2. .Location: \*a. County Yolo b. Address 516 F Street

\*c. City Davis Zip 95616

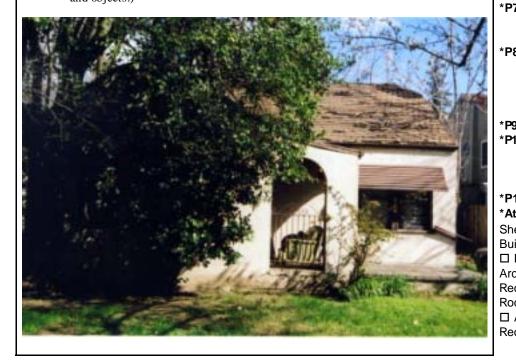
**P5. Photograph or Drawing** (Photograph required for buildings, structures, and objects.)

This small revival style house suggests Mediterranean influence in its stucco finish, arched porch openings and metal miling. Rectangular in plan, it has a side gabl roof with a low pitch. A slightly raised concrete porch extends along the west side of the front façade from the centrally placed entry to the end wall. The entry, which opens to the side (south), is sheltered by asmall, porch covered by a "cat slide" roof, which is supported on arches that open to two sides. This porch entry is an important visual focus of the front façade and plays a major role in establishing a stylistic reference for the house. Windows are wooden casements with single light glazing. An aluminum awning over the front window obscures the fenestration pattern, but is removable. The house is clad in stucco. Although in poor condition, the integrity of design, materials, workmanship, setting, location, feeling and association remains intact. The house contributes to a district eligible for the California Register.

View east
